Mount Post-Modification Analysis Report (3) 12.50-Ft Sector Frames

April 30, 2025 Site ID: *5000270666-VZW / DAMEN AND FOSTER - A* Page | 3

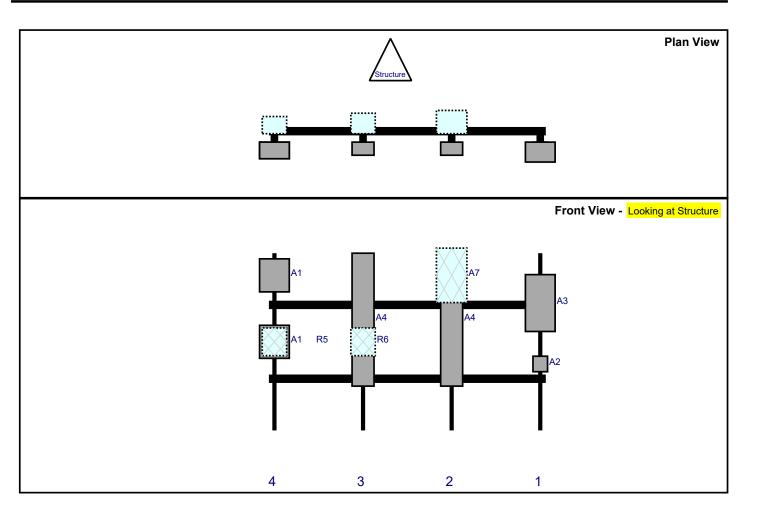
Page: 1

Height	Width	H Dist	Pipe	Pipe	Ant	C. Ant	Ant		
Ref#	Model	(in)	(in)	Frm L.	#	Pos V	Pos	Frm T.	H Off	Status	Validation
A2	4408 w/ KRE 105 281/1	8.4	7.9	147	1	а	Front	60	0	Retained	
A3	AIR 6449	30.8	16.1	147	1	а	Front	27	0	Retained	
A4	NHH-65B-R2B	72	11.9	99	2	а	Front	36	0	Retained	
A7	RC3DC-3315-PF-48	29.5	16.5	99	2	а	Behind	12	0	Retained	
A4	NHH-65B-R2B	72	11.9	51	3	а	Front	36	0	Retained	
R6	8843	15	13.2	51	3	а	Behind	48	0	Retained	
A1	39GHz VectaStar NR gNB	17.9	16.1	3	4	а	Front	12	0	Added	
A1	39GHz VectaStar NR gNB	17.9	16.1	3	4	b	Front	48	0	Added	
R5	4449	15	13.2	3	4	а	Behind	48	0	Retained

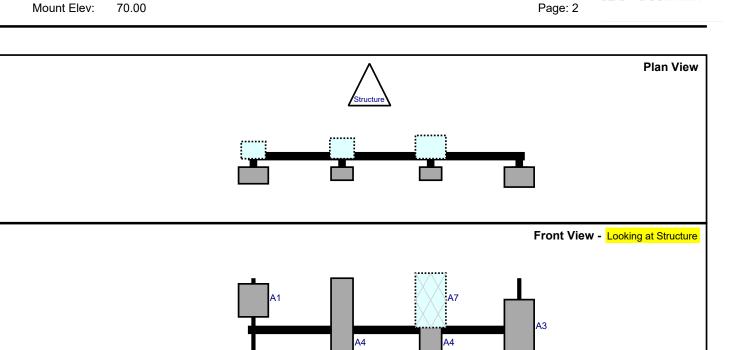
Page: 2

В Sector:

Height	Width	H Dist	Pipe	Pipe	Ant	C. Ant	Ant		
Ref#	Model	(in)	(in)	Frm L.	#	Pos V	Pos	Frm T.	H Off	Status	Validation
A2	4408 w/ KRE 105 281/1	8.4	7.9	147	1	а	Front	60	0	Retained	
A3	AIR 6449	30.8	16.1	147	1	а	Front	27	0	Retained	
A4	NHH-65B-R2B	72	11.9	99	2	а	Front	36	0	Retained	
A7	RC3DC-3315-PF-48	29.5	16.5	99	2	а	Behind	12	0	Retained	
A4	NHH-65B-R2B	72	11.9	51	3	а	Front	36	0	Retained	
R6	8843	15	13.2	51	3	а	Behind	48	0	Retained	
A1	39GHz VectaStar NR gNB	17.9	16.1	3	4	а	Front	12	0	Added	
R5	4449	15	13.2	3	4	а	Behind	48	0	Retained
